**NOVEMBER 2005 SITE SURFACE REGRADING  
AND DRAINAGE IMPROVEMENTS  
NEAR CALCINE CAP, TRONOX INC.  
SODA SPRINGS, IDAHO FACILITY**

February 27, 2006

GLOBAL ENVIRONMENTAL TECHNOLOGIES L.L.C.

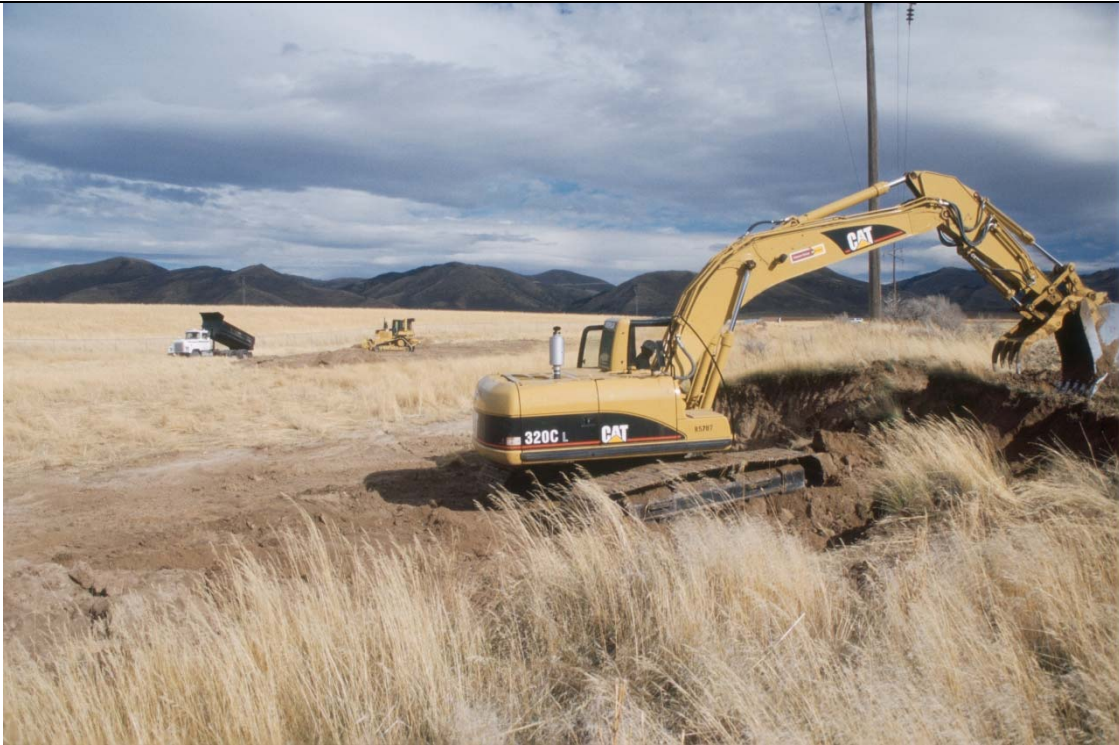
LOOKING EAST-NORTHEAST – BREAKING GROUND ON INFILTRATION BASIN.  
CALCINE CAP BEHIND THE EQUIPMENT AND FENCE LINE IN BACKGROUND

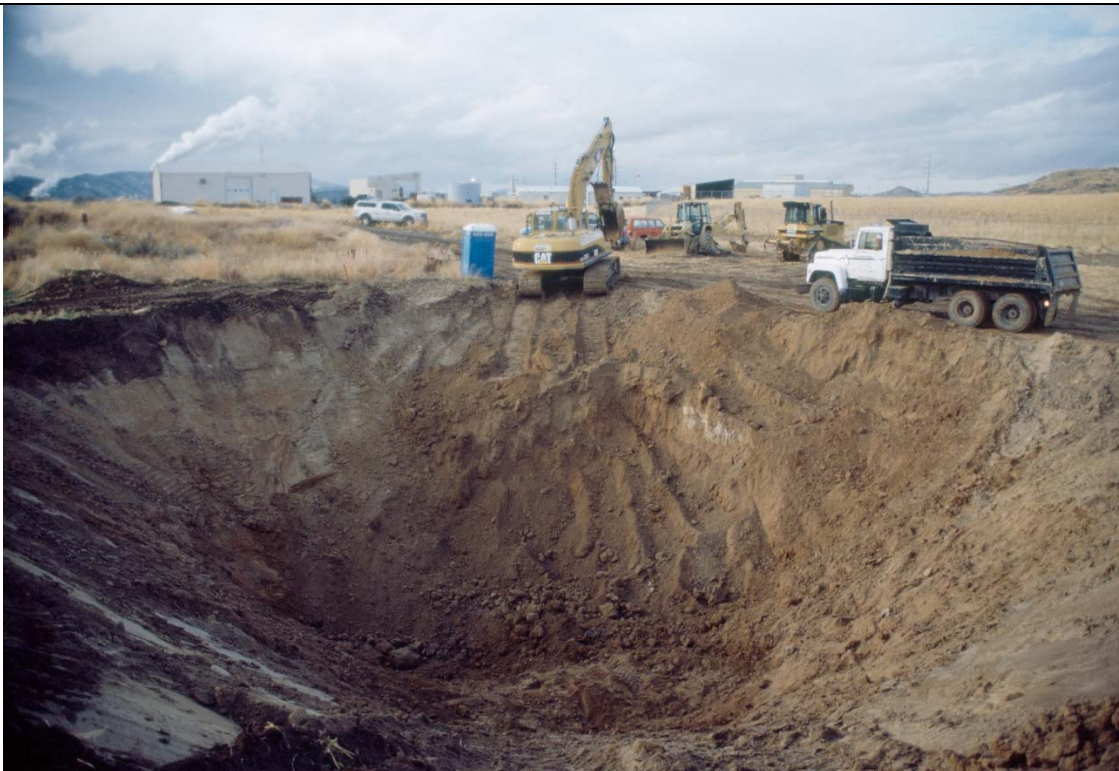
LOOKING WEST-NORTHWEST ACROSS INFILTRATION BASIN EXCAVATION

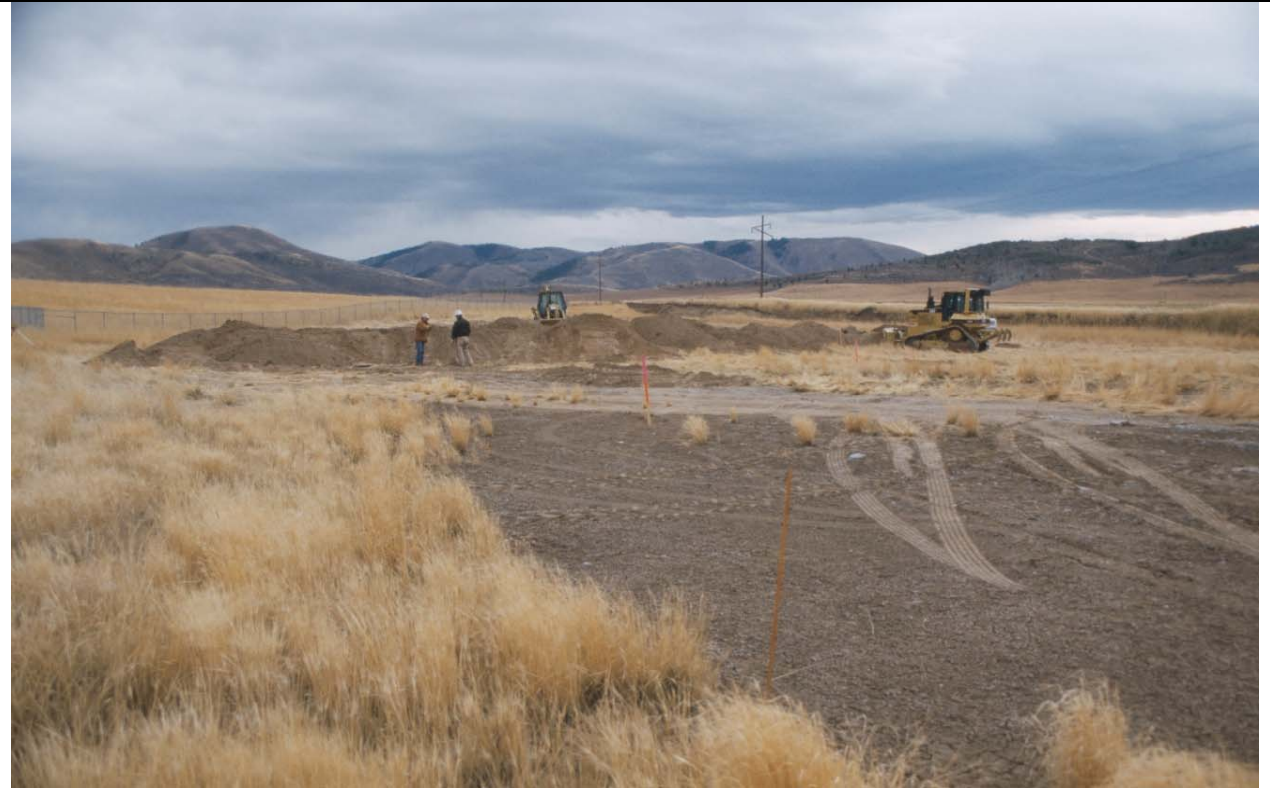
LOOKING EAST- RAISING GRADE IN SETTLED AREA FORMER SCRUBBER POND

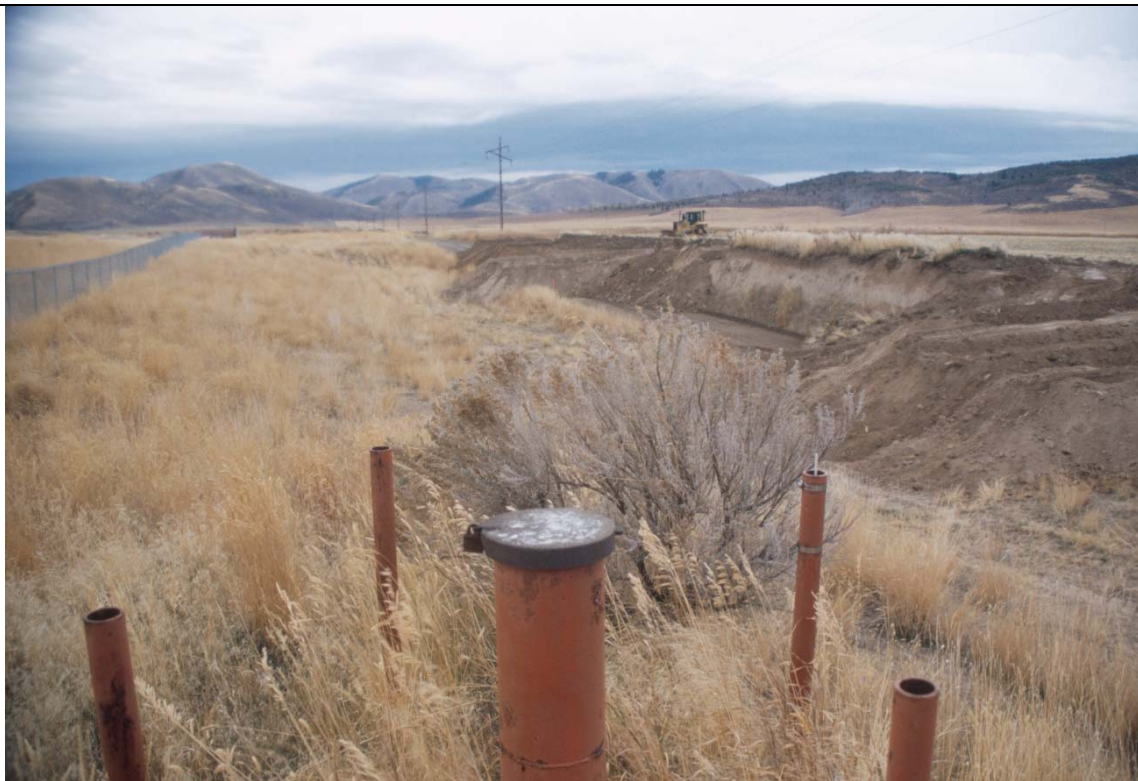
LOOKING EAST – MAKING CUTS TO PROVIDE FILL - WELL KM-2 IN FOREGROUND

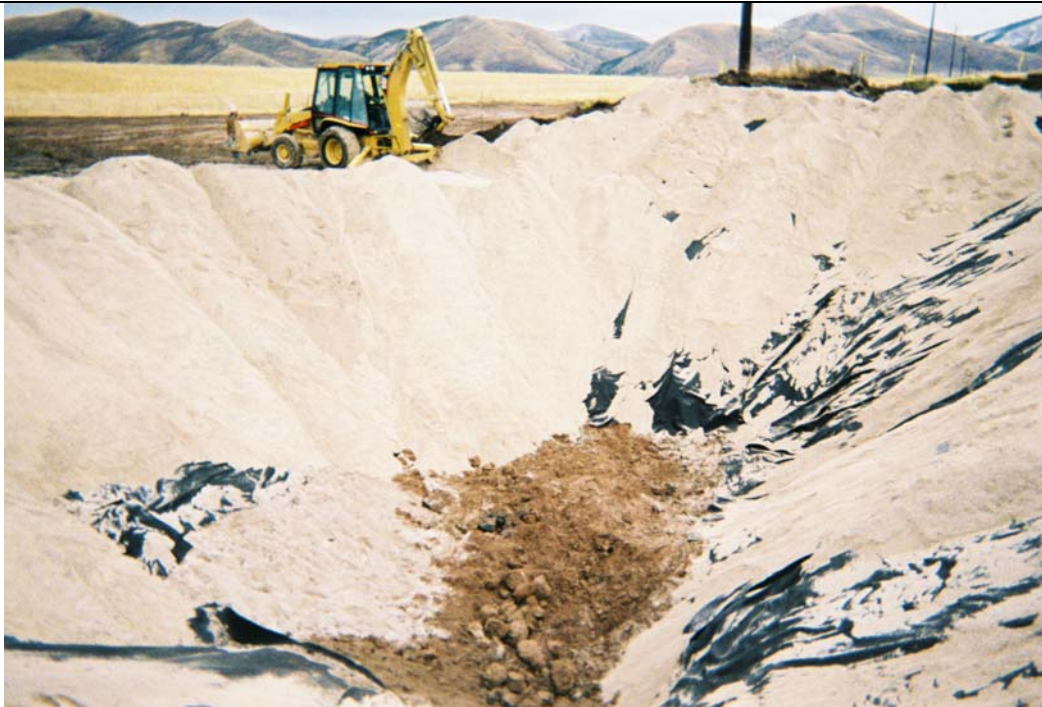
LOOKING NORTHEAST ACROSS BASIN – PLACING SAND IN BASIN FOLLOWING  
PLACEMENT OF NONWOVEN GEOTEXTILE – BEDROCK EXPOSED IN BOTTOM OF  
EXCAVATION

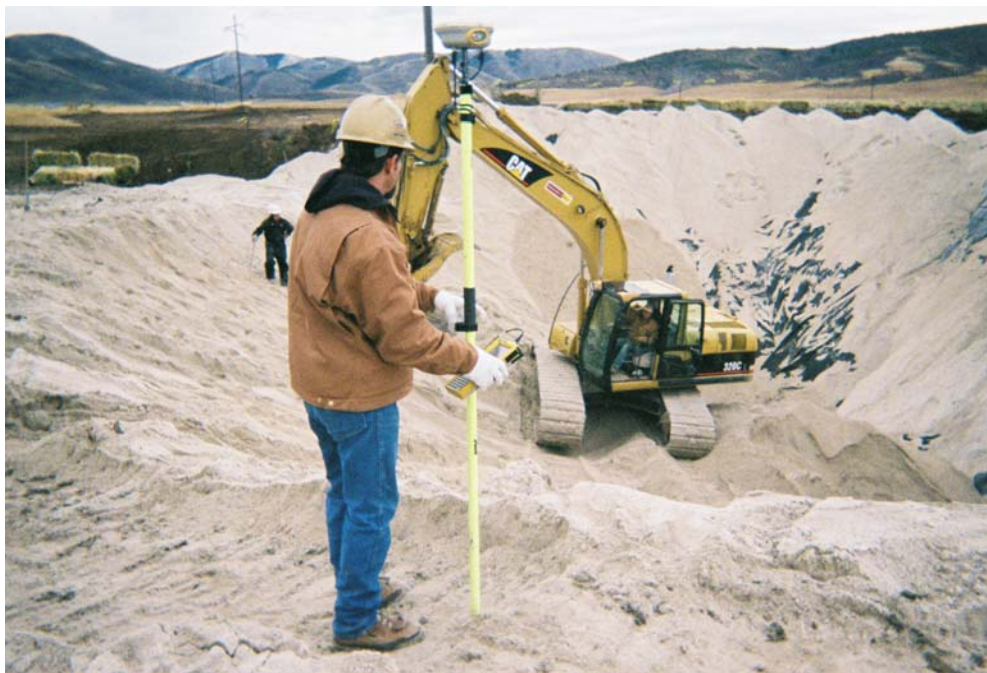
LOOKING EAST-SOUTHEAST – PERFORMING SURVEY, SAND PLACEMENT

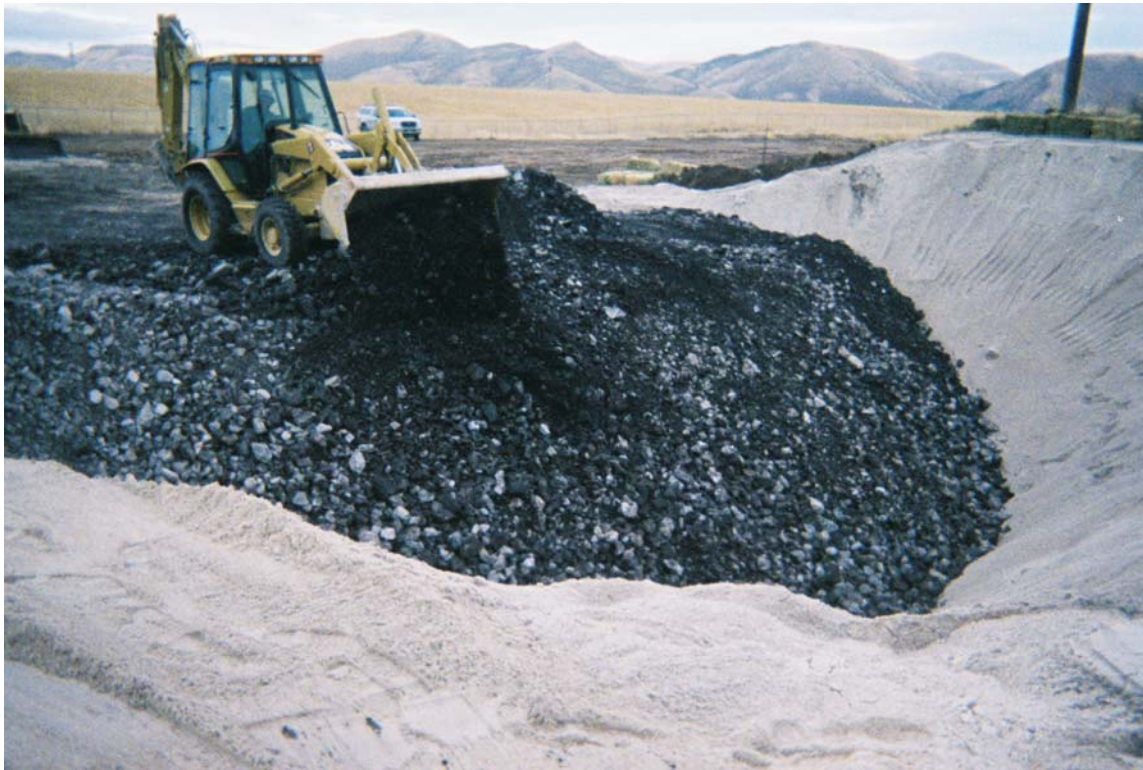
LOOKING EAST-NORTHEAST – COARSE LIMESTONE PLACEMENT ON SAND FILTER

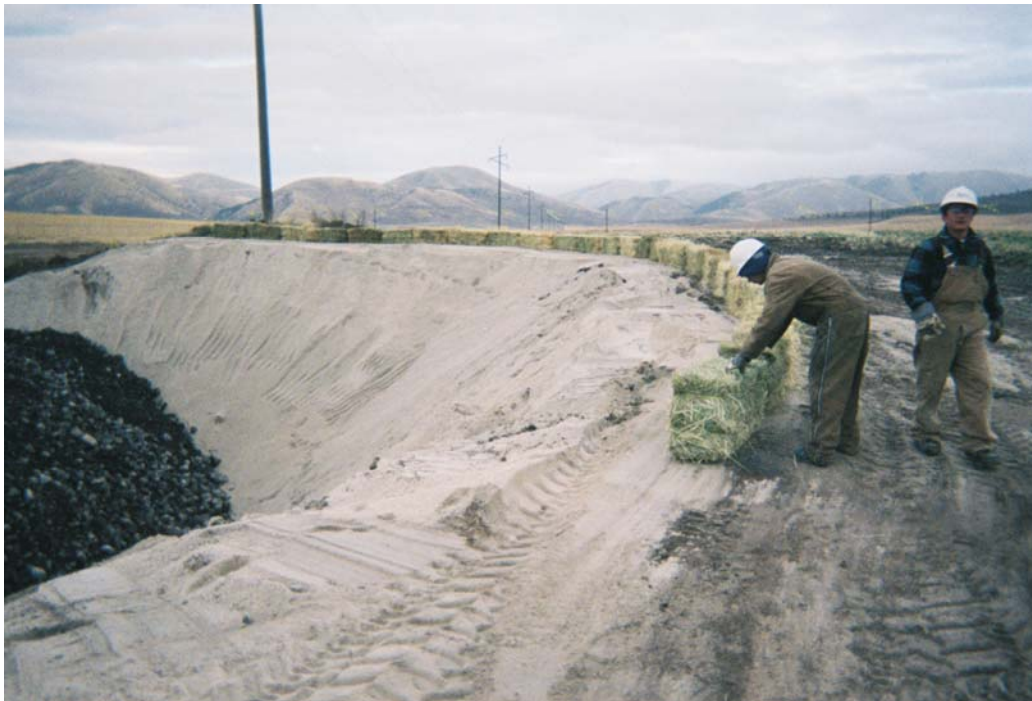
LOOKING EAST ACROSS INFILTRATION BASIN - PLACING SEDIMENT BARRIER

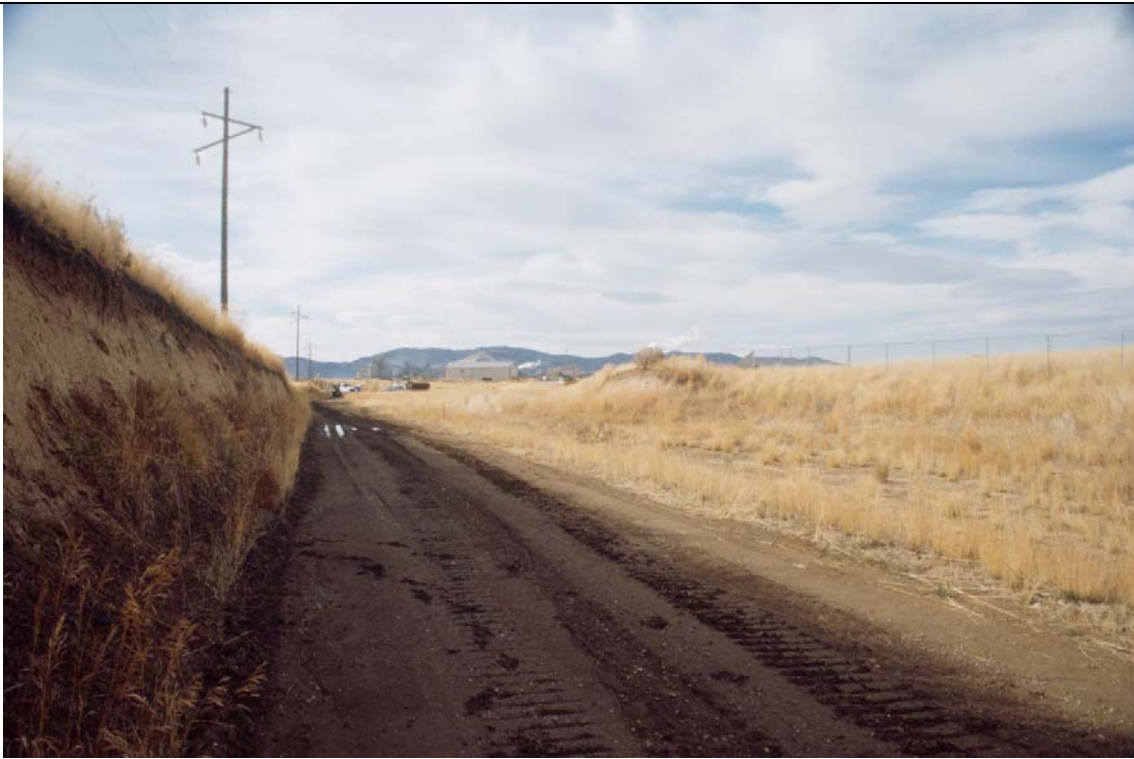
LOOKING WEST – PRIOR TO FILL - CALCINE CAP ON RIGHT

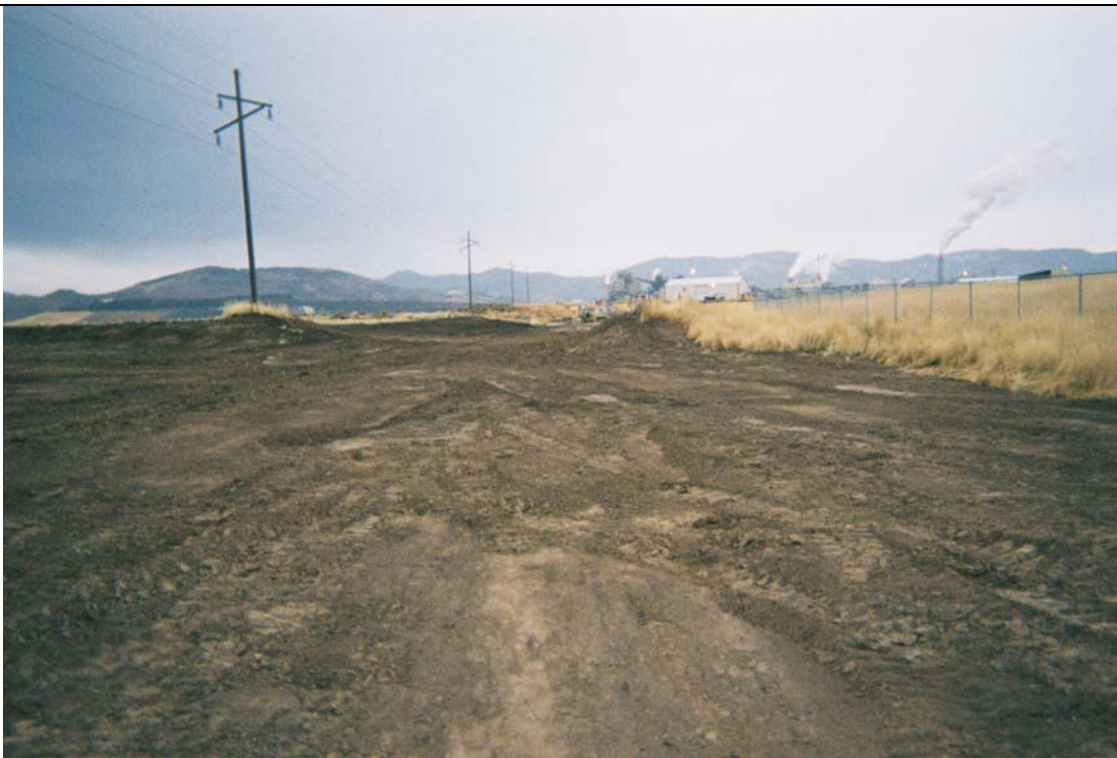
LOOKING WEST – FOLLOWING PLACEMENT AND COMPACTION OF FILL AND PRIOR TO SMOOTHING NEAR SAME LOCATION AS TOP PHOTO - CALCINE CAP ON RIGHT

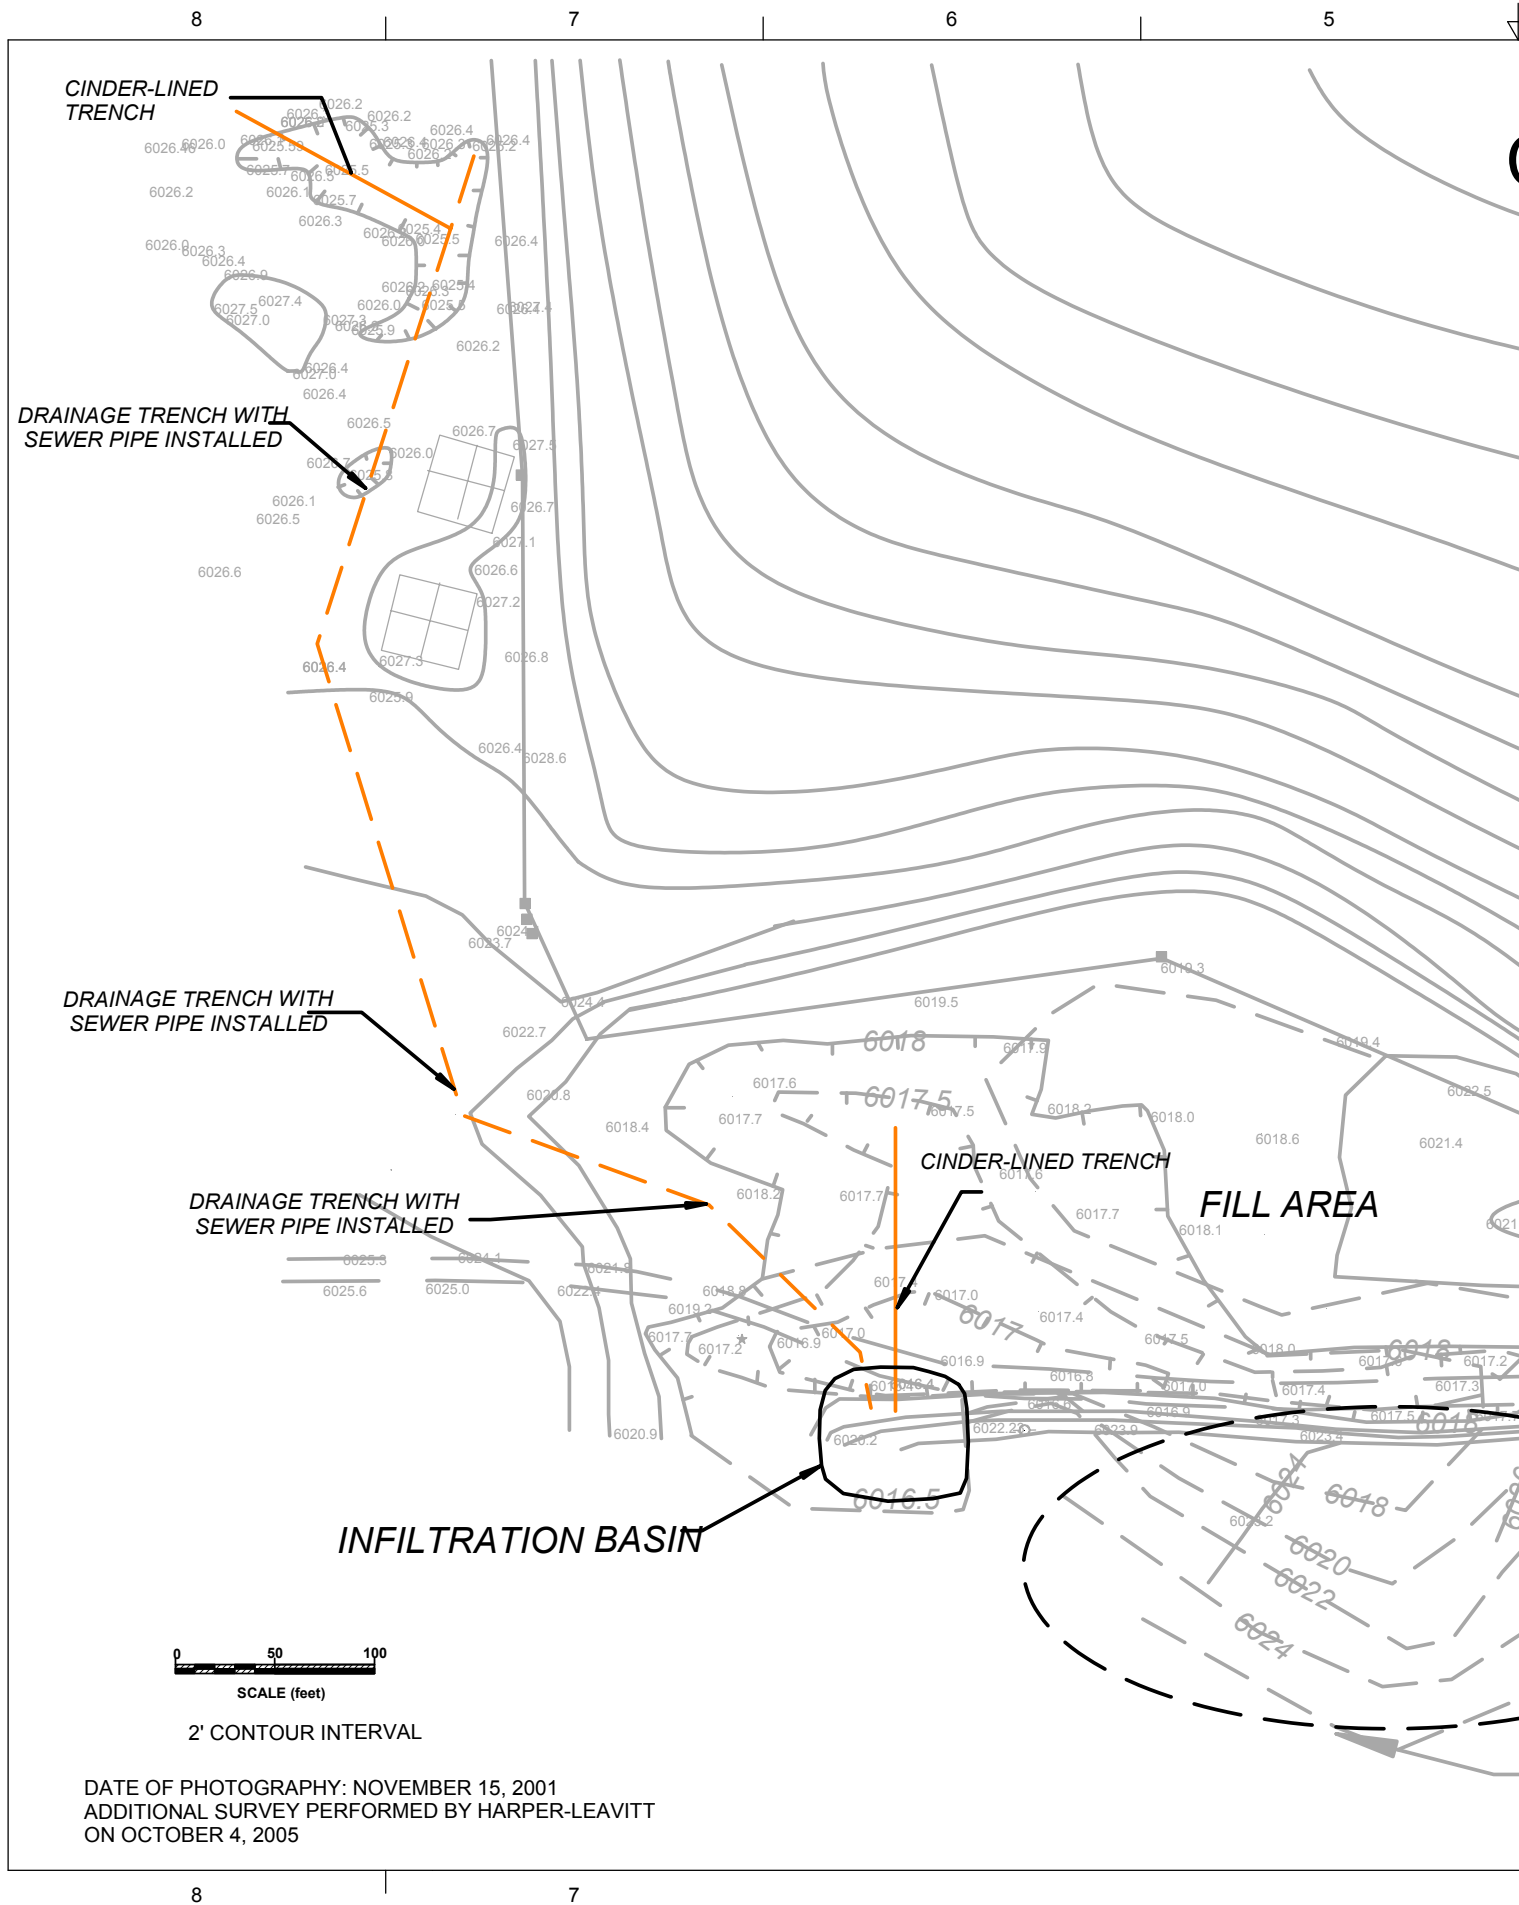
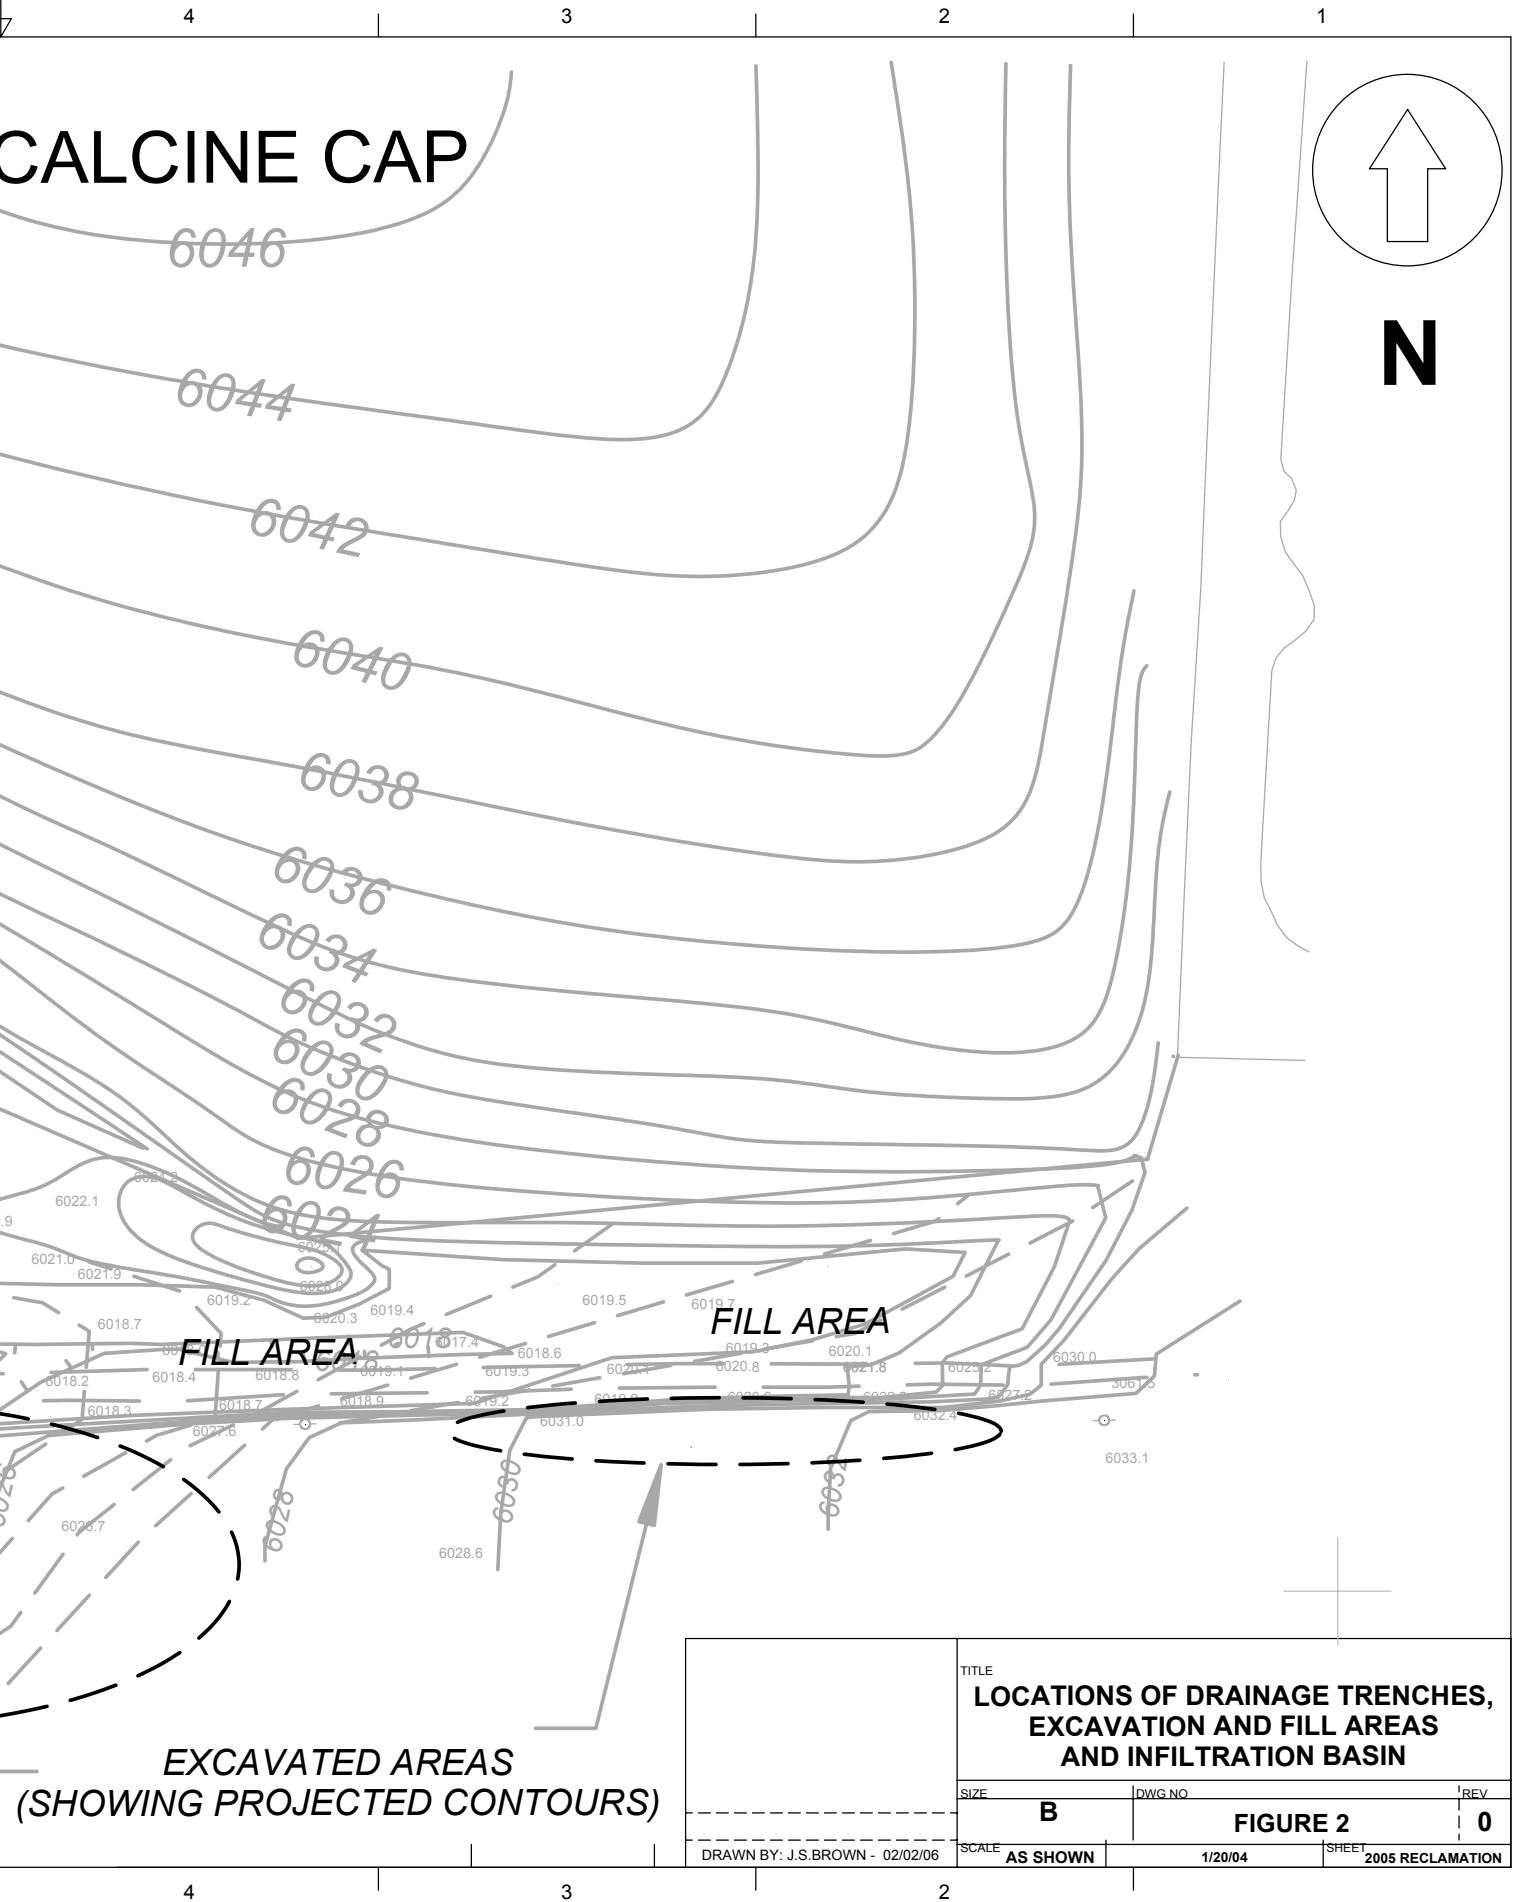
TITLE LOCATIONS OF DRAINAGE TRENCHES, EXCAVATION AND FILL AREAS AND INFILTRATION BASIN			
SIZE B	DWG NO FIGURE 2	REV 0	
DRAWN BY: J.S.BROWN - 02/02/06	SCALE AS SHOWN	1/20/04	SHEET 2005 RECLAMATION

Approximately 1,000 feet of drainage trench were excavated to convey surface water to the south toward the basin. Trenches were excavated using a John Deere 301D rubber tire backhoe. The trenches were designed to maintain a 1.5 degree or greater slope to the south to convey runoff from the southwest corner of the cap. Trench width was a nominal 2 foot width, with variable depth to maintain positive grade for drainage. Four-inch SDR-21 perforated PVC sewer drain pipe was placed in the drainage trenches following excavation, bedded and backfilled to above original grade using ¾-inch clean washed cinder materials. In areas where shallow trenching could not accommodate the drain pipe, trenches were left open and lined with cinders. The cinder and drain pipe in the trenches were wrapped using non-woven filter fabric. Positive grade was maintained to the south using survey laser level measurements.

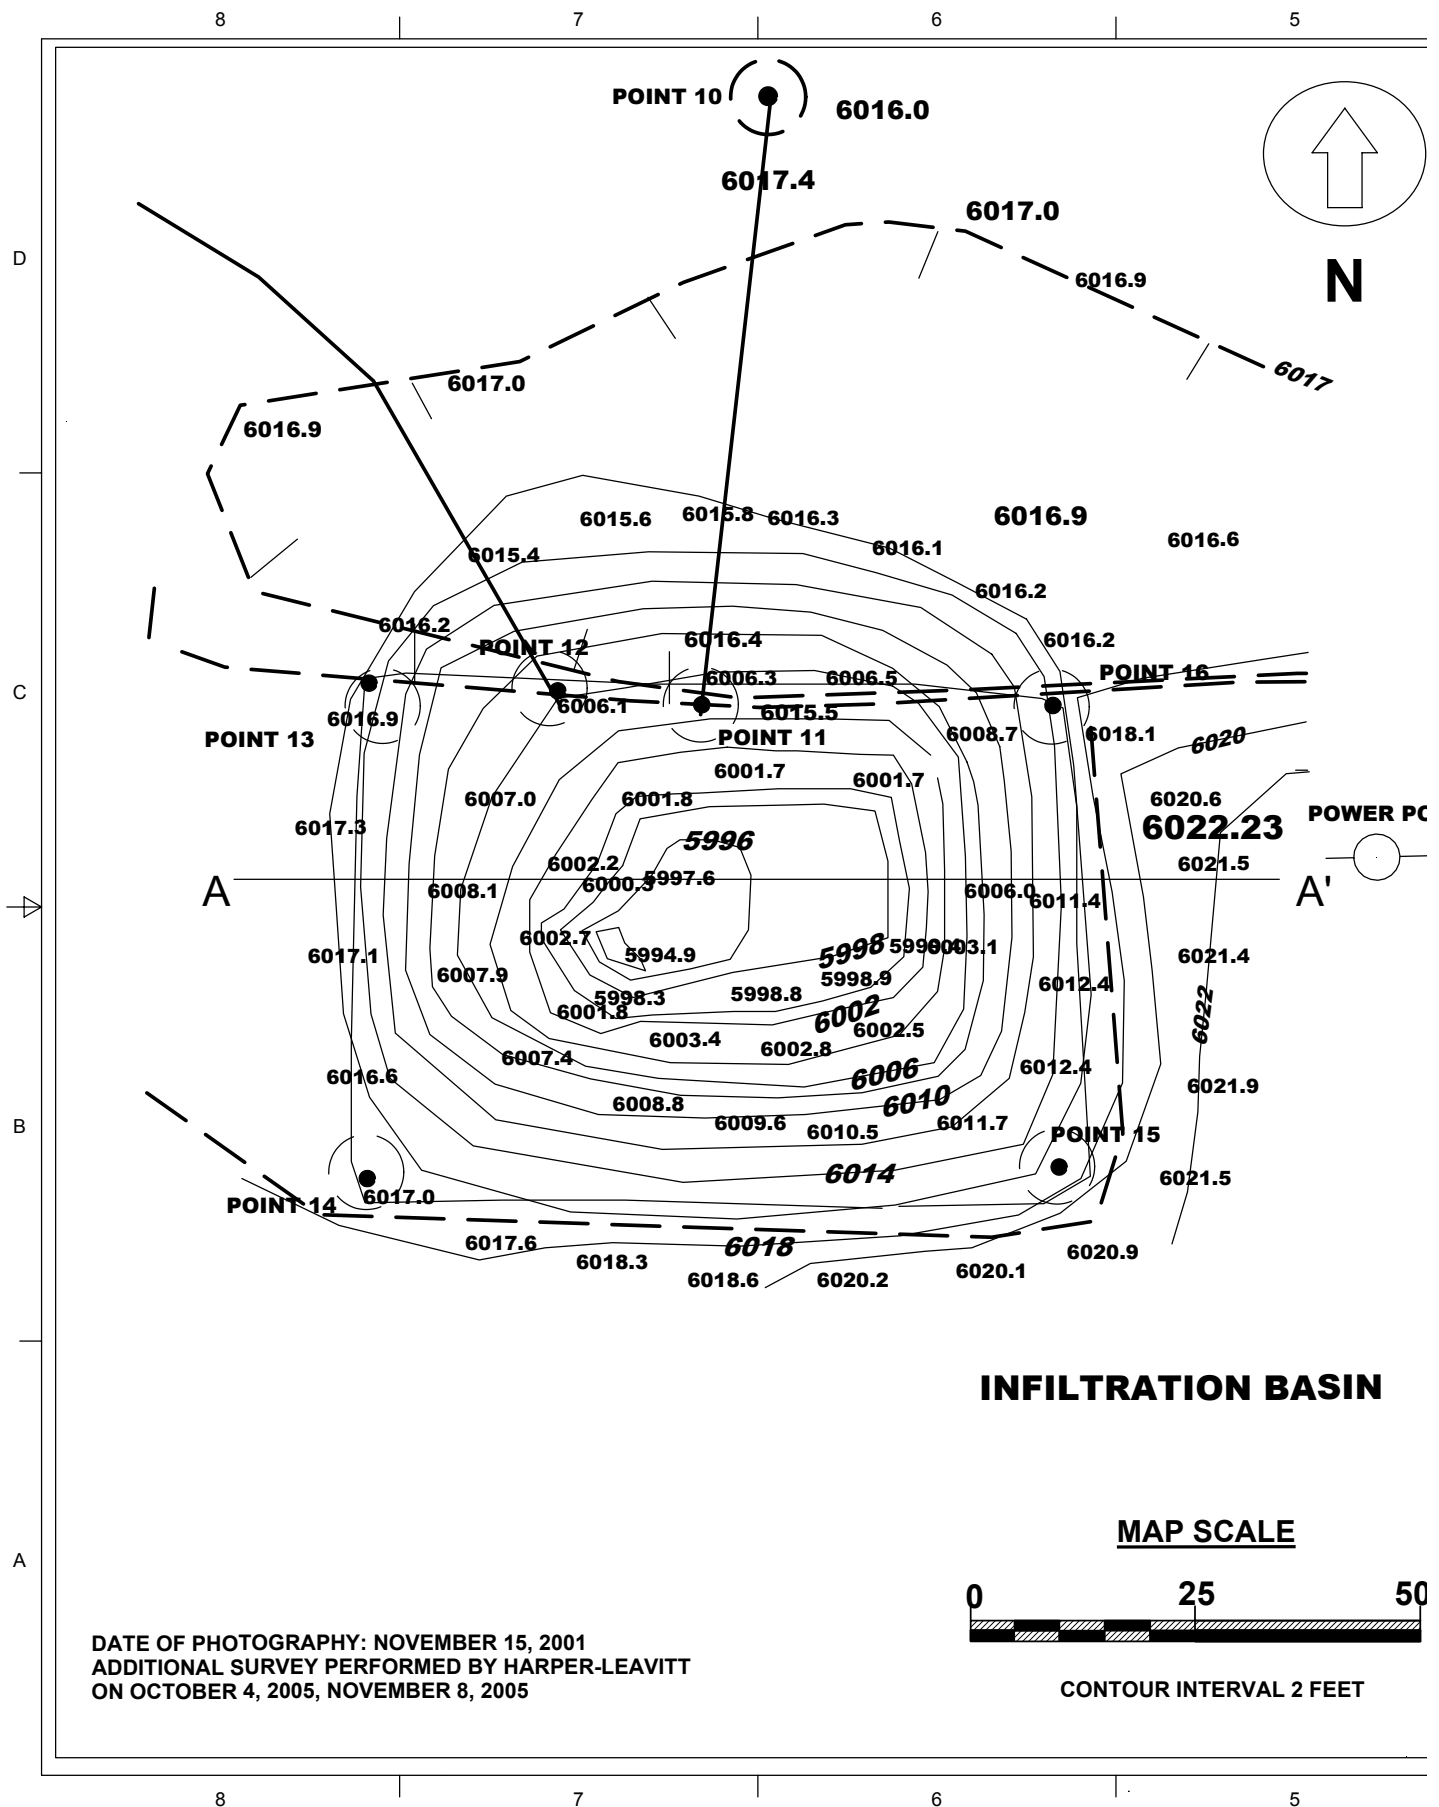
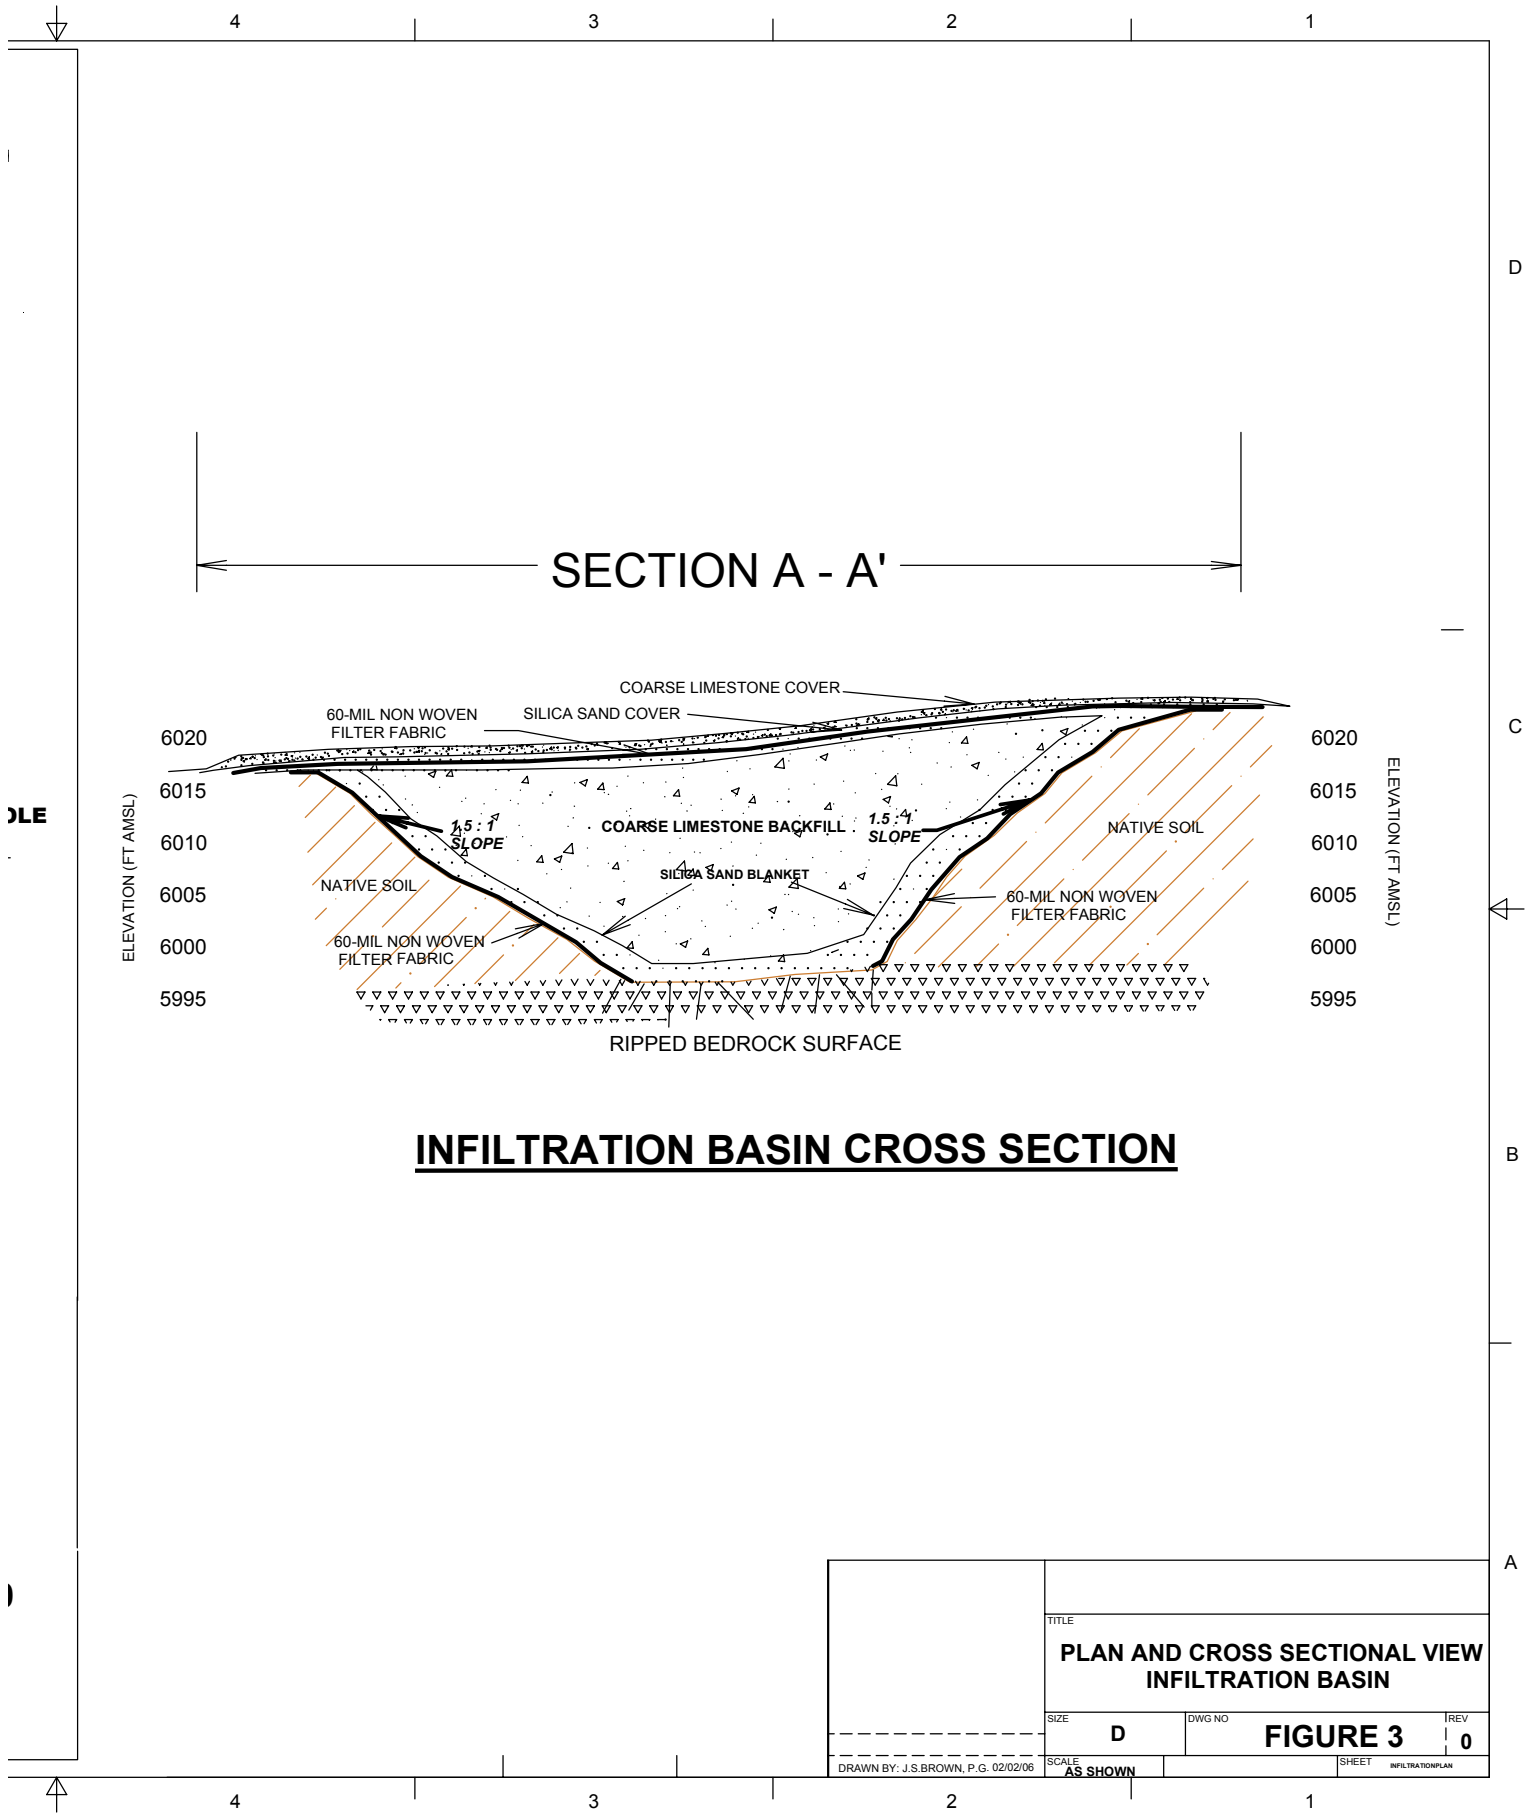
TITLE			
PLAN AND CROSS SECTIONAL VIEW INFILTRATION BASIN			
SIZE	D	DWG NO	REV
		FIGURE 3	0
DRAWN BY: J.S.BROWN, P.G. 02/02/06	SCALE	SHEET	
	AS SHOWN	INFILTRATION PLAN

The infiltration basin was excavated in native soil (silt and clay) to bedrock at a depth of about 22 feet. Basin dimensions were about 80 by 80 feet at the ground surface with side slopes of approximately 1.5:1. Only native soils were encountered, and no soils exhibiting characteristics or odor of the former scrubber pond were encountered. Following excavation of the basin to bedrock, the bedrock surface was ripped by the contractor using a CAT D5 dozer and CAT 320CL extended boom trackhoe. A non-woven geotextile filter fabric was placed along the sides of the basin prior to adding filter sand. An 18 to 24-inch layer of silica sand was then placed within the basin on the geotextile filter fabric. Coarse limestone backfill was placed into the basin to within about one foot of the ground surface. Approximately 2,200 yards of limestone and sand

were placed within the basin as backfill. Following completion of the coarse limestone backfill, the contractor installed a sand filter blanket cover to approximately 9 inches above grade and placed a geotextile fabric layer within the sand to about 2 feet beyond the edge of the basin. The contractor then installed about one foot of coarse limestone cover as armoring material to bring the infiltration basin above surrounding grade. Construction details are shown on Figure 3.
